Rebuttal Statement

Prepared by Jason Karasinski, IAAI-CFI, NAFI- CFEI

This Rebuttal Statement is being provided to address the data points raised within the reports submitted on behalf of the Defendant, HP. The scope of my investigation was to provide a report as it pertains to the origin and cause of the fire (Case Identification - Marcellin and Estate of Hollowell v. HP Inc., and Staples, Inc. United States District Court, Western District of New York.)

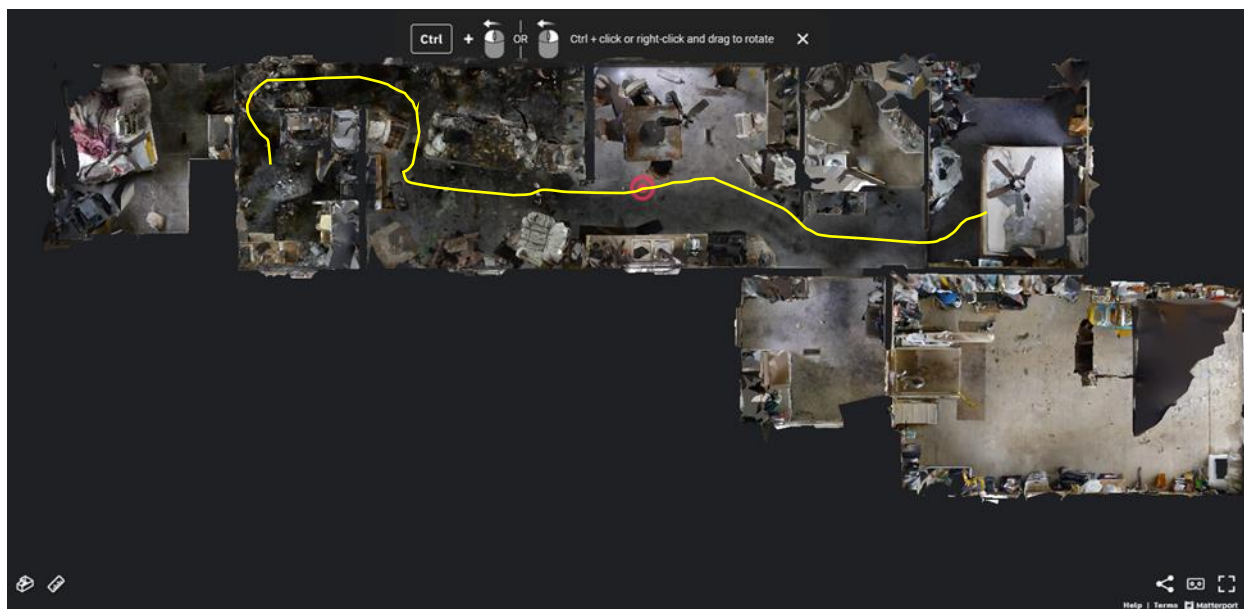
Figure 2: Path traveled by the occupant that discovered the fire.

In Figure 1 above Mr. Myers states that he cannot eliminate the electric couch as a potential ignition source. Mr. Myers fails to mention or consider that the occupant of the structure who is also the eyewitness, Ms. Marcellin, passed through this room to get to the office. Ms. Marcellin, traveled past this couch prior to discovering the fire in the office (see deposition of Ms. Marcellin.) After entering the office and discovering the fire she went back to the kitchen to retrieve a fire extinguisher, traveling past the couch again. After obtaining the fire extinguisher and going back to the room of origin, passing the couch again. No fire was ever observed at the couch and is consistent with her statements and traveling past this couch no less than four times. All damage to the couch is consistent with the heat layer extending to the couch as it progressed through the structure. Based on witness statements and observations the potential of a candle as the ignition source can also be eliminated.

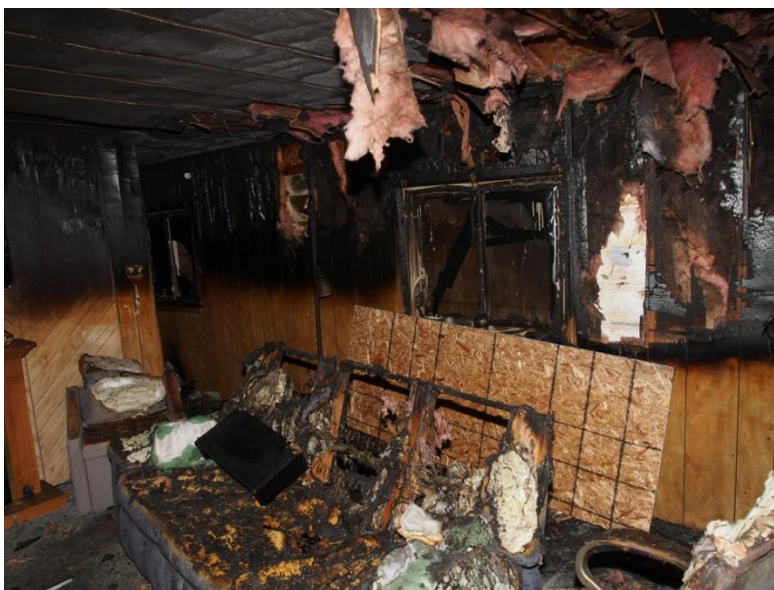
Figure 3: Livingroom couch remains.

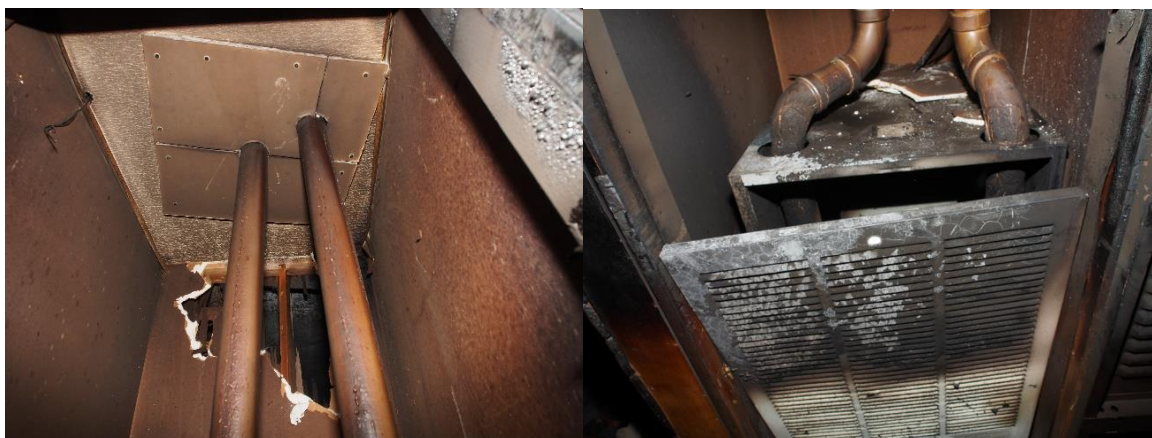
Figure 5: Left photo depicts heat and smoke damage no fire. The right photo depicts ventilation damage.

Based joint scene exam observations, witness statements, fire patterns, and fire dynamics, a fire originating at the furnace has been eliminated. No fire was ever observed at the time the witness inspected it. This is consistent with her statements of physically opening the closet door and visually inspecting the furnace. It should be noted that she would have passed the furnace as well no less than four times.

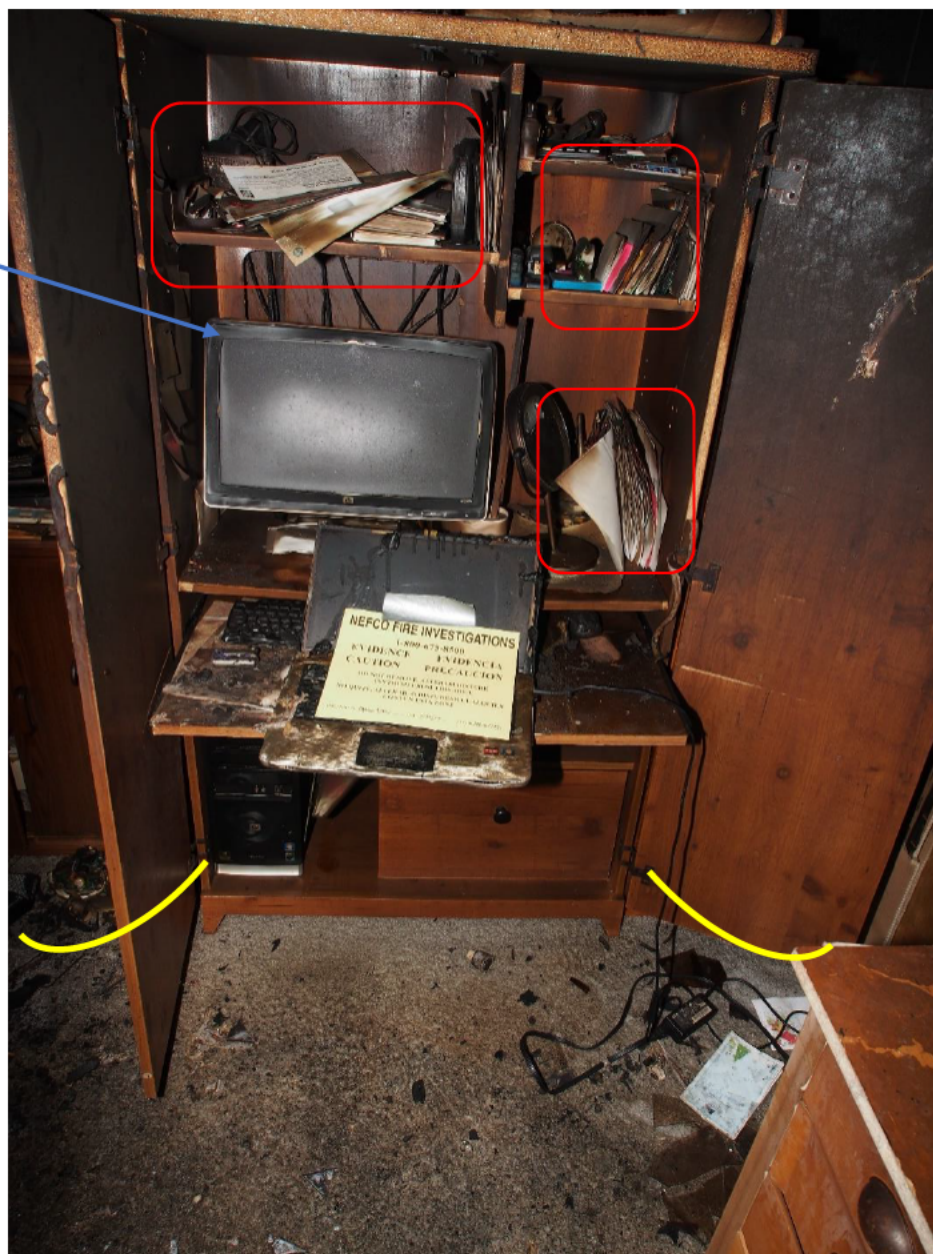
Figure 7: Location of subject HP Pavilion Laptop

Figure 7, depicted above are yellow lines showing that the hinges allow the armoire doors to fully open to be parallel with the front of the unit. The blue arrow depicts the HP monitor on the desk behind the HP Pavillion Laptop. The HP monitor has less thermal damage than the laptop positioned directly in front. The red squares depict lighter weight combustibles that show different stages of thermal, smoke, and fire damage.

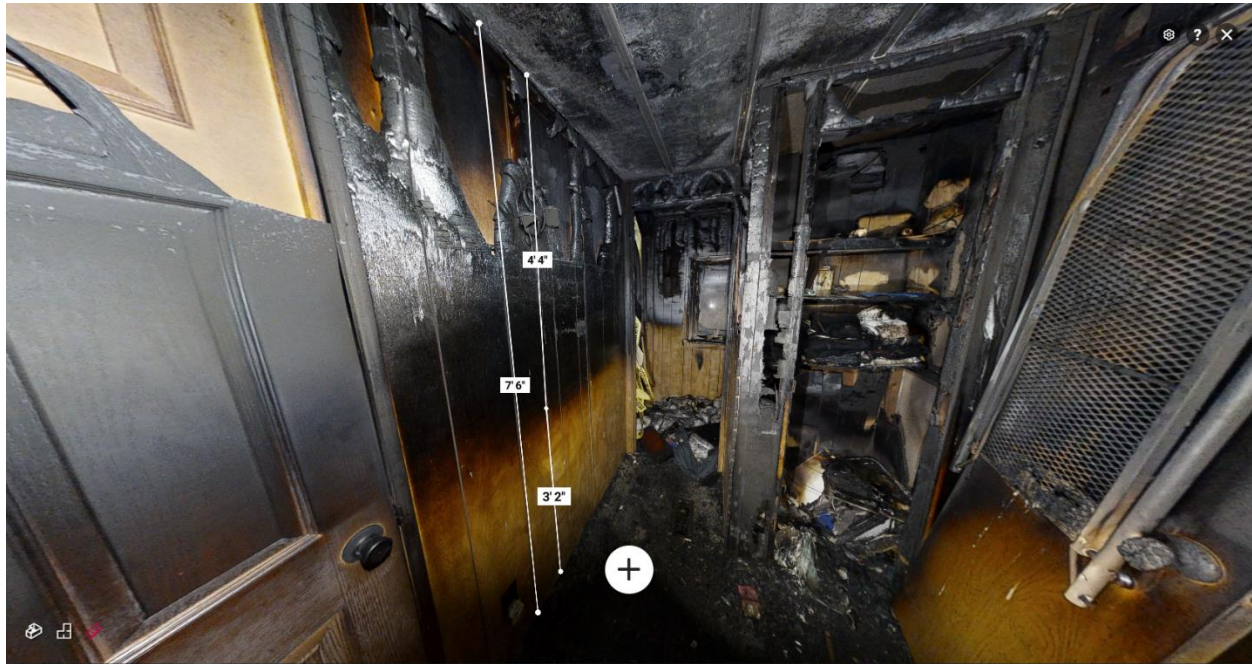
Figure 8: Measurements recovered by the Matterport of the HP expert on site.

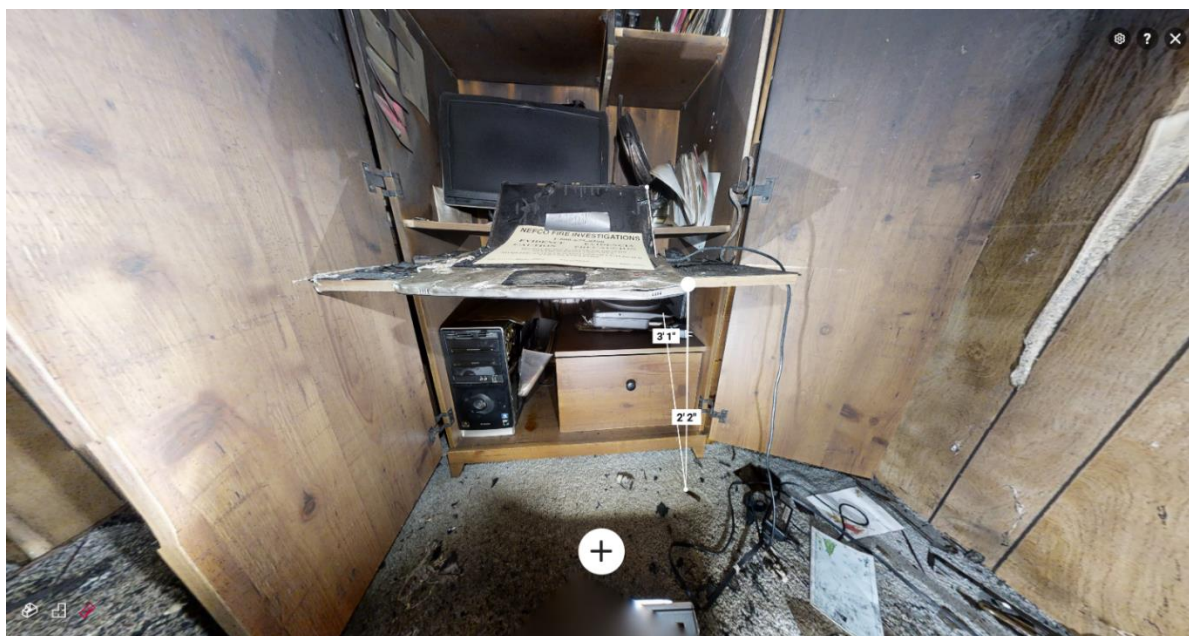
Figure 10: Measurements recovered by the Matterport of the HP expert (Greg Gorbett) on site.

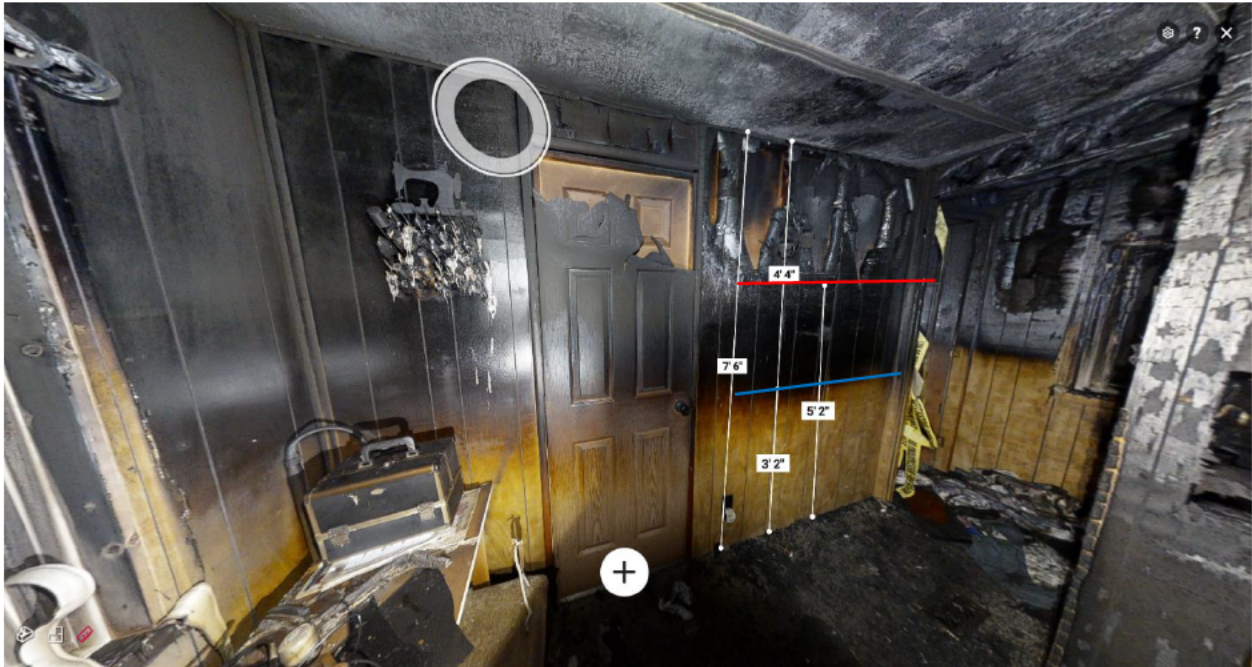
Figure 12: Matterport of the room of origin showing heights on wall.

Figure 12 and Figure 13 contradict statements made by Mr. Horn and Mr. Myers. In Figure 12, you can see the line of demarcation noted in blue which is higher than the HP Pavilion on the armoire. The red line denotes the height of the witness based on Figure 13. It is obvious that the occupant discovered the incident prior to the thermal heat layer reaching the laptop in question. This clearly demonstrates that any heat layer impacting the laptop occurred after the discovery of the event. This eliminates the possibility that the heat layer had reached the level of the laptop prior to Ms. Marcellin observing the projectiles coming from the laptop.

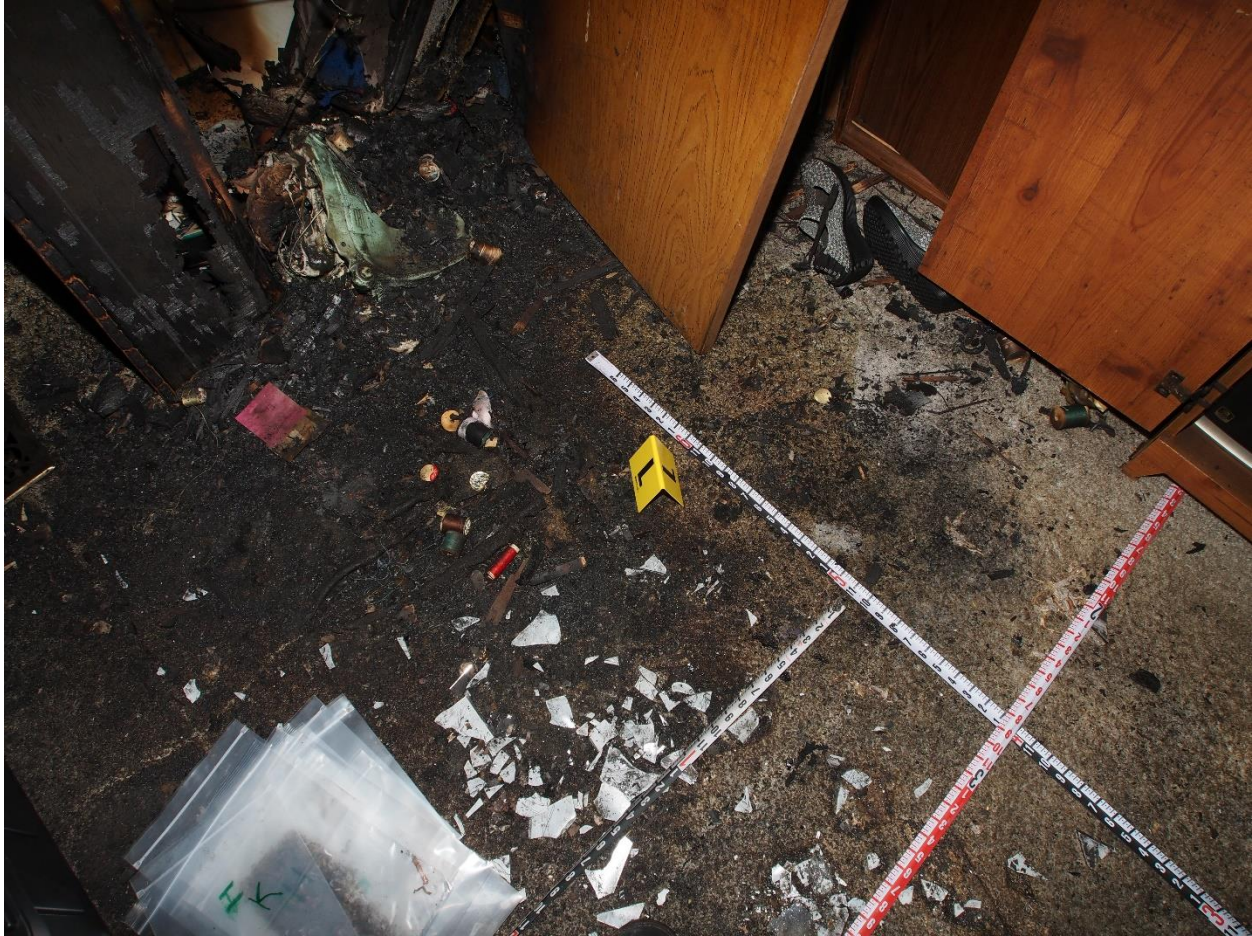
Figure 17: Prior to closet scene processing; excavation and debris collection.

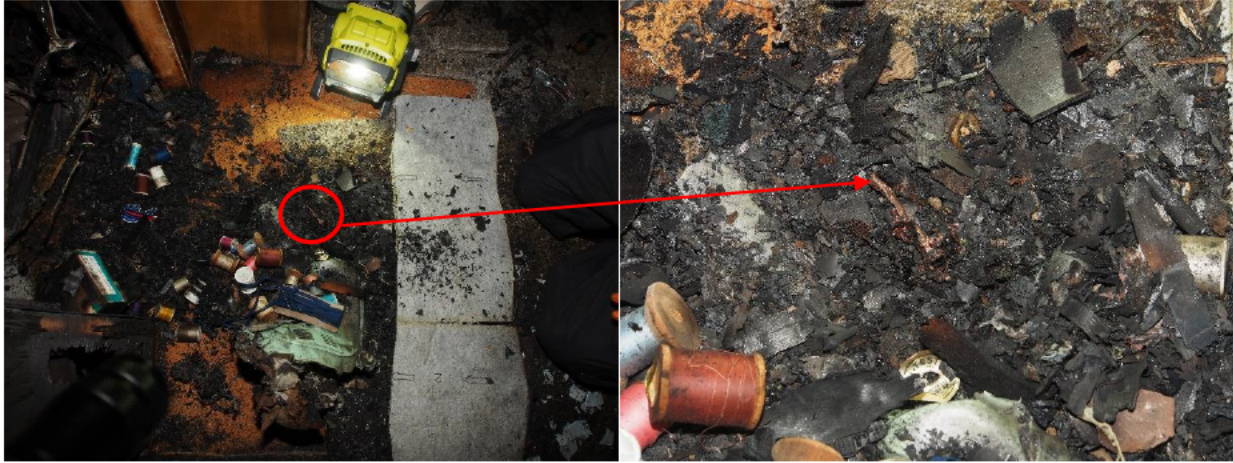
Both Mr. Horn and Mr Myers opine that there was no evidence of battery remains within the closet debris. This statement is not accurate, please see photos below.

Figure 18: During the systematic processing of the closet. The carpet was removed to provide a clean area to process closet debris. The left photo and red circle outline the battery remains. The foil identified in the photo above came out of the closet with the debris from the green basket.

A joint lab exam was conducted again with HP present at our forensic facility. The debris within the closet was inspected on site as well as sifted at the joint lab examination. The opportunity was available again for the battery remains to be observed as well as the location it was secured at the structure.
